+ PICO[◇] sNPWT clinical cases

PICO[◇]
Single Use Negative Pressure
Wound Therapy System

Preventive use of PICO^o sNPWT after Achilles tendon surgery

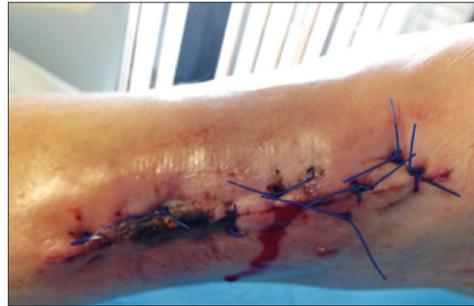
Day 0

Start of PICO sNPWT

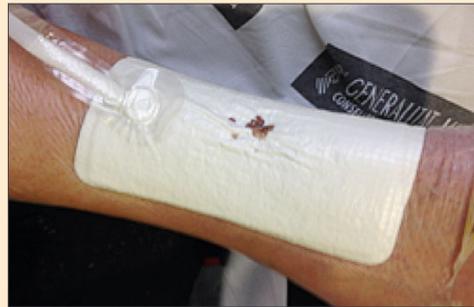
Application of PICO sNPWT

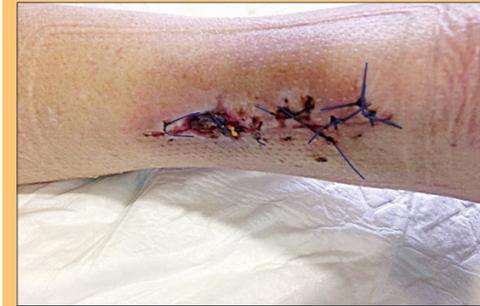
**Day 5**

Follow-up at 5 days

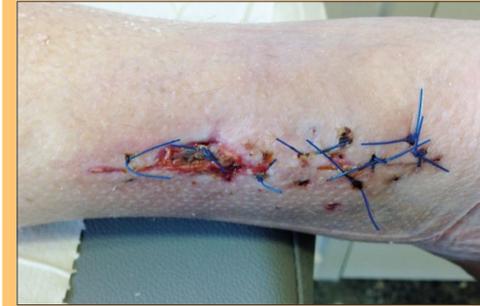
**Day 7**

Follow-up at 7 days
End of PICO treatment

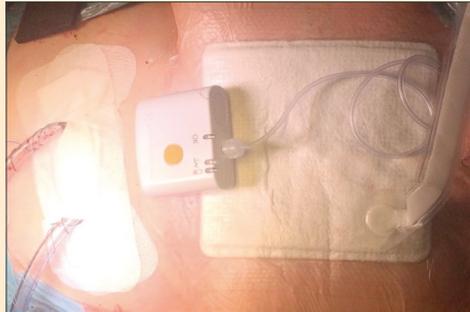
Application of the PICO sNPWT System in the operating theatre

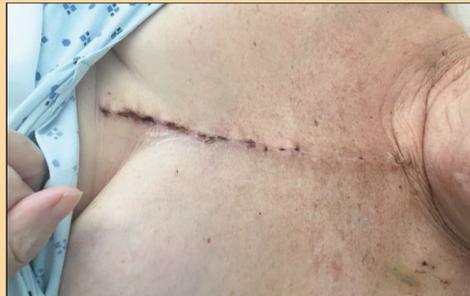
End of PICO sNPWT treatment Follow-up at 7 days

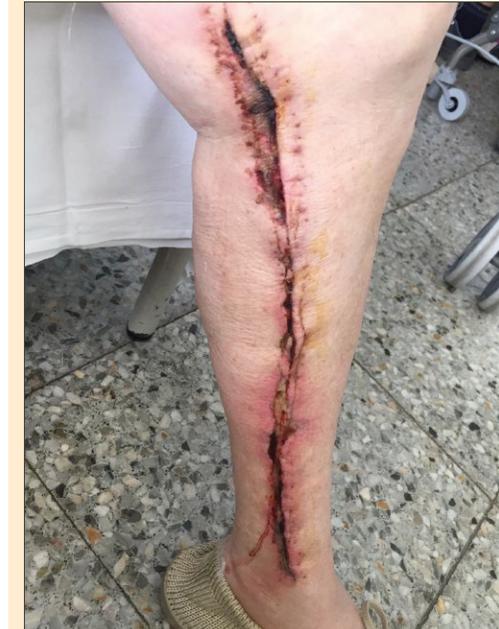
Wound NOT treated with PICO sNPWT Follow-up of saphenectomy at 7 days

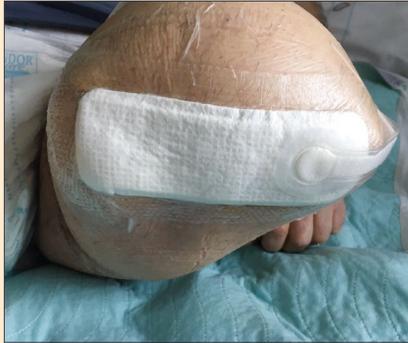
Picture at application day

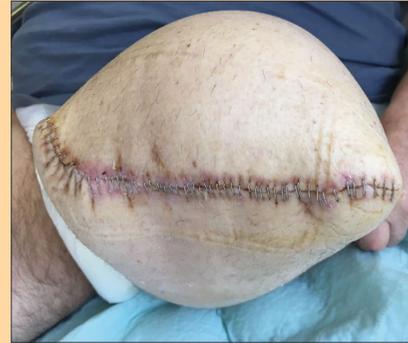
Picture at 7 days

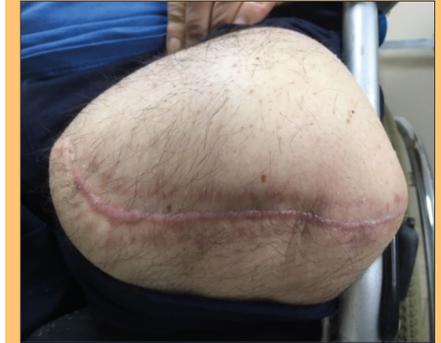
Picture at 3 weeks

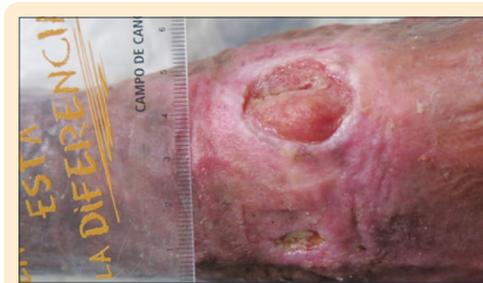
Follow-up one week after autologous micrografting in combination with negative pressure wound therapy (PICO).

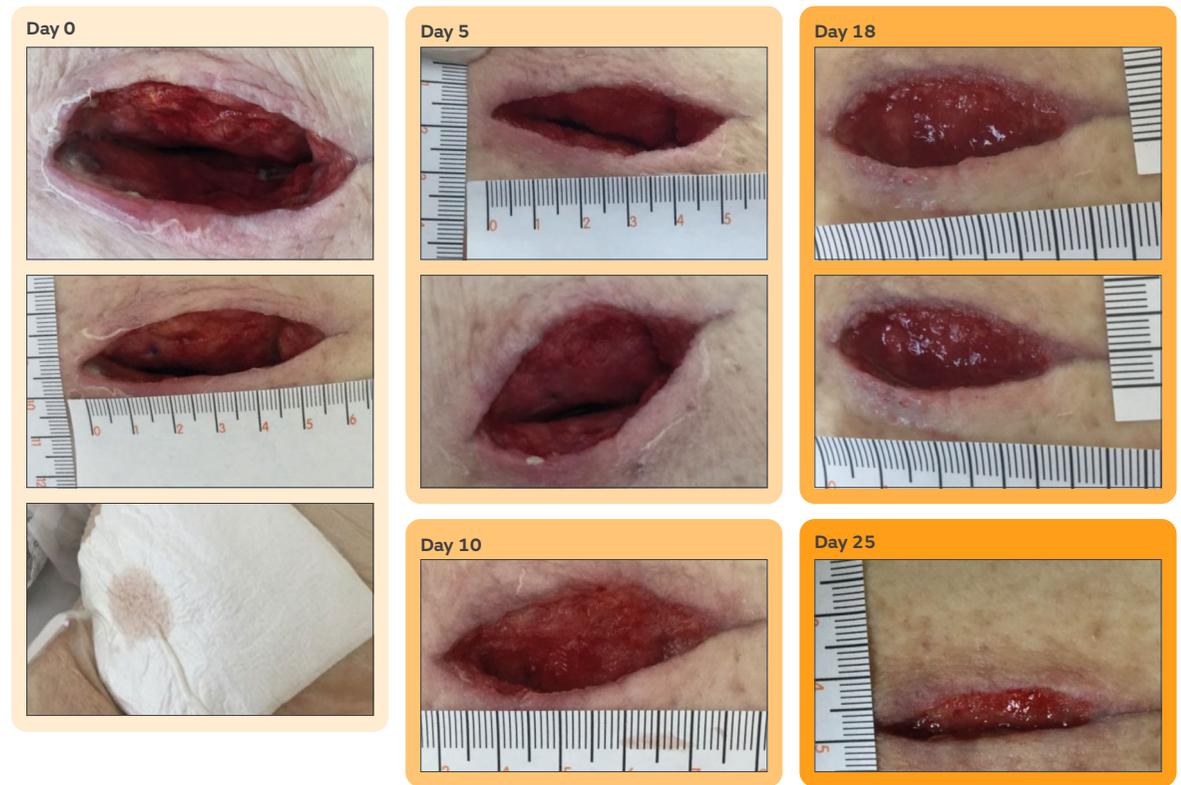
Table. Evolution of wound

Lenght (cm)	Width (cm)	Depth of the cavity (cm)	Wound surface area (cm ²)	Wound cavity volume (cm ³)
Day 0	5.7	2.0	4.7	11.4	53.58
Day 10	4.5	1.5	3.0	6.75	20.25
Day 18	3.7	1.0	1.3	3.70	4.44
Day 25	3.0	0.5	0.5	1.50	0.75
Day 28	2.5	0.5	Epidermisation phase, PICO sNPWT therefore discontinued	1.25	Not mesurable
Difference in 28 days	3.2	1.5	4.7	10.15	53.58

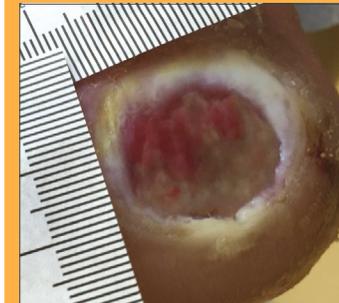
Figure 5, day 28
Wound measured 2x1.7cm

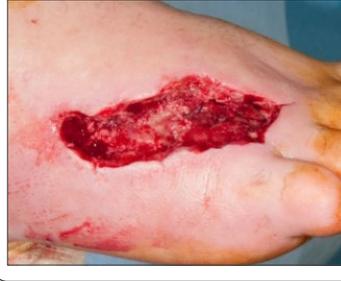
Figure 1
Wound post-surgical debridement

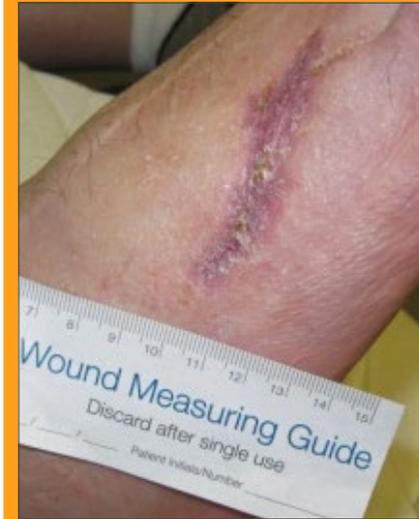
Figure 8
Week 12
Wound completely healed

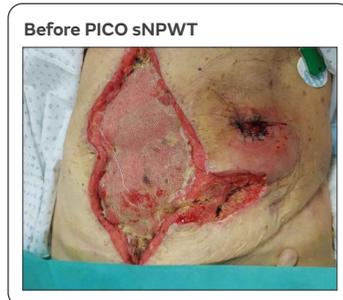
Day 0

Skin graft

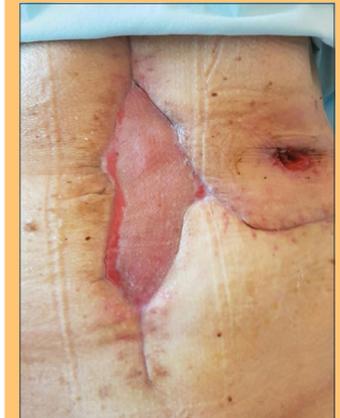
Day 6

PICO sNPWT stops

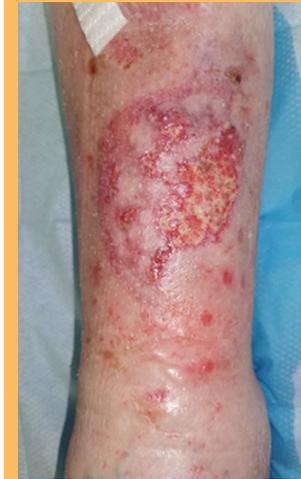
Day 31 (10.46cm²)

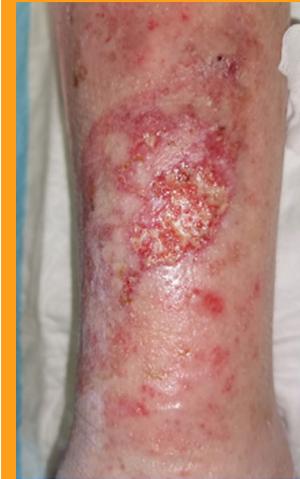
Day 38 (5.75cm²)

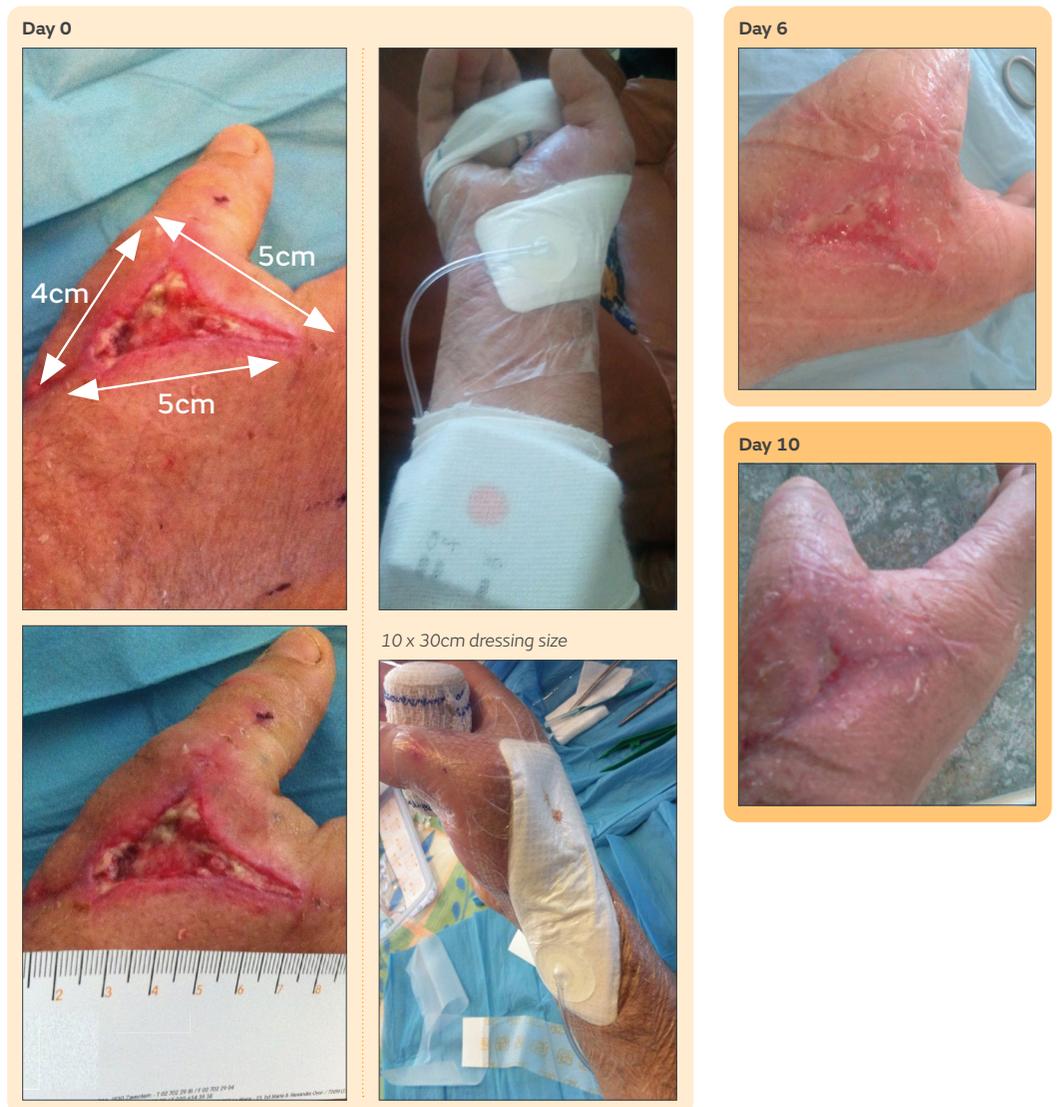
Near-complete healing at day 14 in a patient awaiting admission to Cardiac Surgery for a triple coronary bypass.
