+ Case study

Author: Laura Bushby Tissue Viability Nurse Specialist,
Northamptonshire Healthcare Foundation Trust.

The use of PICO[®] 7 Single Use Negative Pressure Wound Therapy device (sNPWT) to kick-start healing for a chronic abdominal surgical wound following dehiscence.

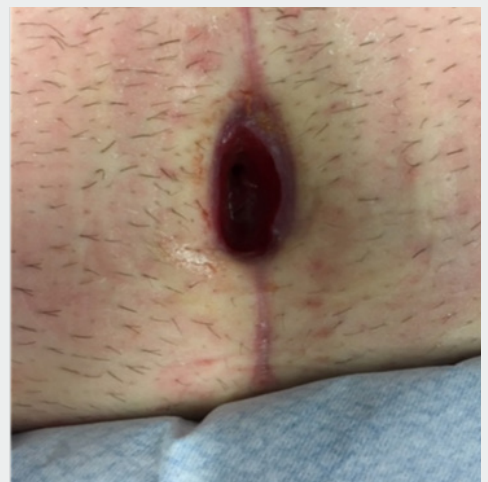
Image 1: Taken at initial tissue viability assessment

On initial assessment by the TV team the wound was dehiscd below the umbilicus on the abdomen, measurements were 3cm (L) x 1.5cm (W), with a depth of 1cm with undermining towards umbilicus of 2cm. The wound bed was clean with no signs of necrosis or slough, there were no clinical signs of infection.

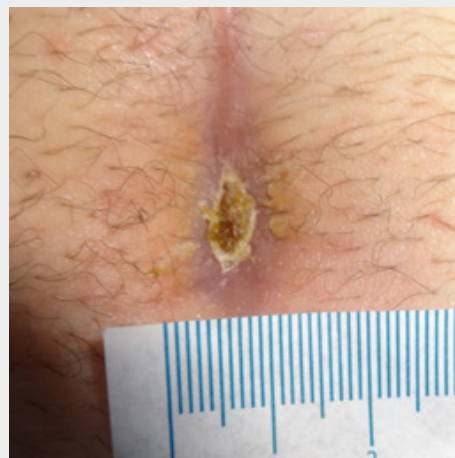
Image 4: Wound healed with dry scab intact, patient discharged from care of Practice Nurses

Following assessment and recommendations from the tissue viability team it took the wound 3 weeks to achieve complete healing. Dressing use reduced from daily to twice weekly and the patient no longer needed to attend the practice daily or the weekend clinic for his dressing change, this resulting in a positive impact to his social and personal life.
