RENASYS<sup>®</sup> WOUND+ Dressing Kit with AIRLOCK<sup>®</sup> Technology successfully utilized to promote healing on an open surgical wound following amputation to a lower limb

RENASYS WOUND+, Dressing Kit case study #1

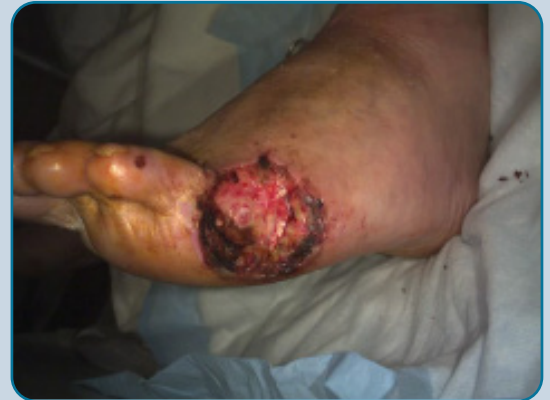
Figure 1

prior to initiating treatment with RENASYS WOUND+ Dressing Kit

LWD:  
4.5 x 4.2 x 0.9cm

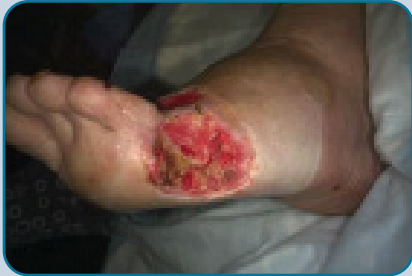
Figure 2

**1 week**

after initiating treatment with  
RENASYS<sup>®</sup> WOUND+ Dressing Kit

Formation of granulation tissue since baseline assessment observed.

LWD:  
4.8 x 4.3 x 0.3cm

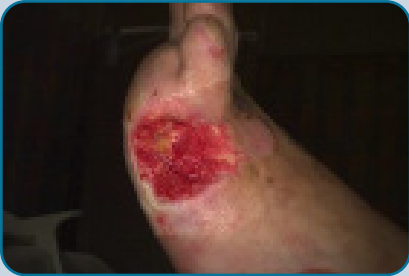
Figure 3

**2 weeks**

after initiating treatment with  
RENASYS WOUND+ Dressing Kit

Increase in granulation tissue observed compared to previous assessments. Wound size reducing

LWD:  
4.5 x 3.4 x 0.4cm

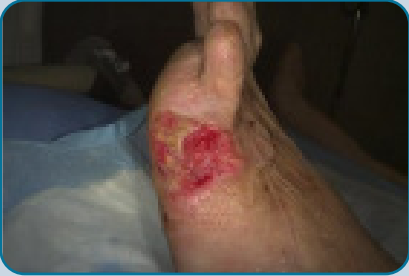
Figure 4

**3 weeks**

after initiating treatment with  
RENASYS WOUND+ Dressing Kit

Granulation tissue continues to have increased since baseline and Week 1 post treatment. Wound size continued to progress toward healing at last visit.

LWD:  
4.1 x 3.1 x 0.5cm

**63% reduction**  
in wound size at the final visit (week 3)
